WEB TECHNIQUES

3" Cam Part #32-1128

CAM ADJUSTMENT MAY BE NECESSARY

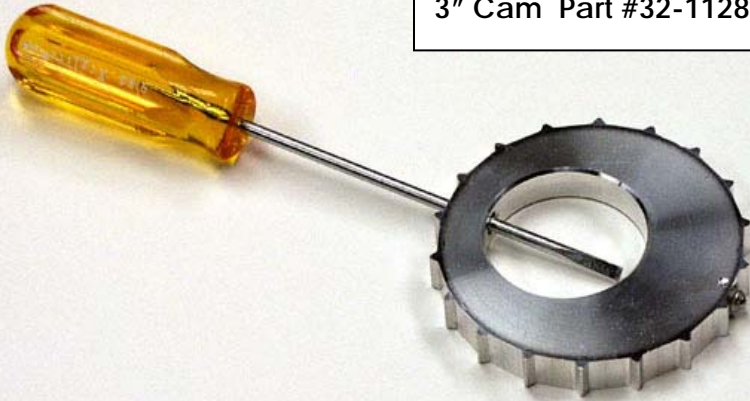
Rapid cam tooth wear can be caused by cores that do not firmly lock onto the coreholder.

This cam has a retractable ball plunger which protrudes from the face of the cam. The ball plunger helps rotate the cam until the teeth firmly grip the inside wall of the core and lock it in place.

The ball plunger has been set for a typical 3" i.d. core. However, it may be necessary to further adjust the ball plunger to fit cores of varying i.d. tolerances.

To adjust, simply insert a 1/8" wide flat blade screwdriver through the back side of the cam (as shown in the picture), into the slot found on the back of the ball plunger and turn clockwise or counter clockwise, as needed, until good locking and releasing operation is attained.
