Removing Burrs From WT-30/35 Drive Shafts

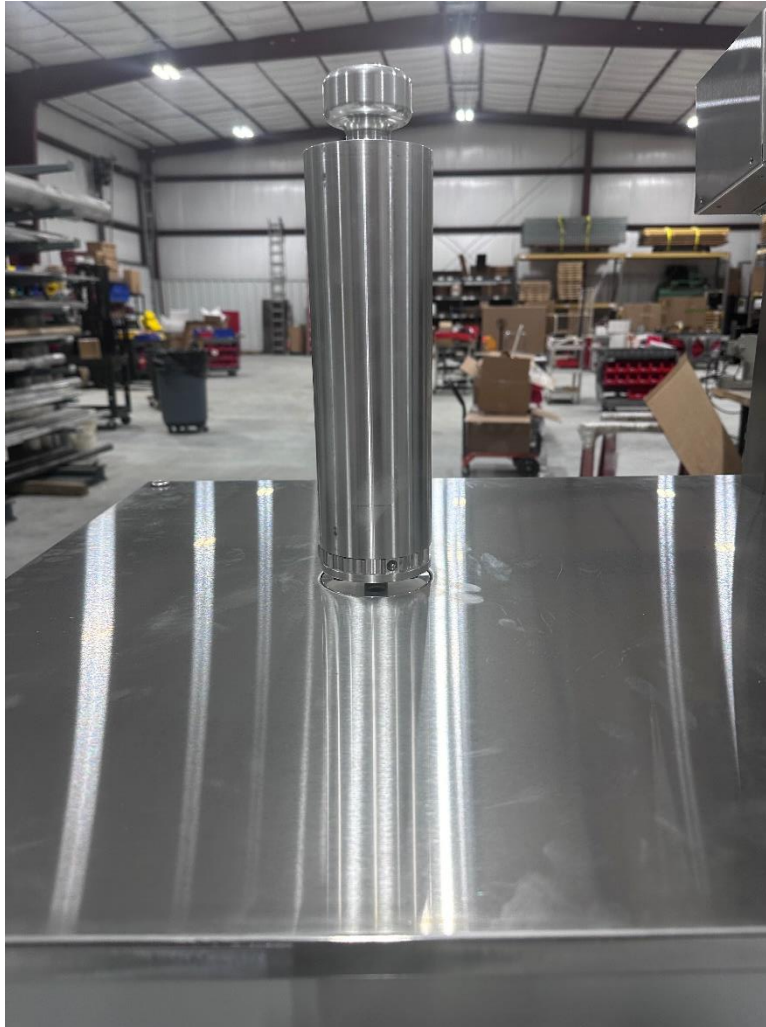
Note: Over time burrs can form on the drive shafts/coreholder shafts causing them to not sit flush with the top of the system. To remove any burrs from the drive shaft/coreholder shaft, follow the instructions below. If not removed this could cause the coreholder to get stuck in the system.

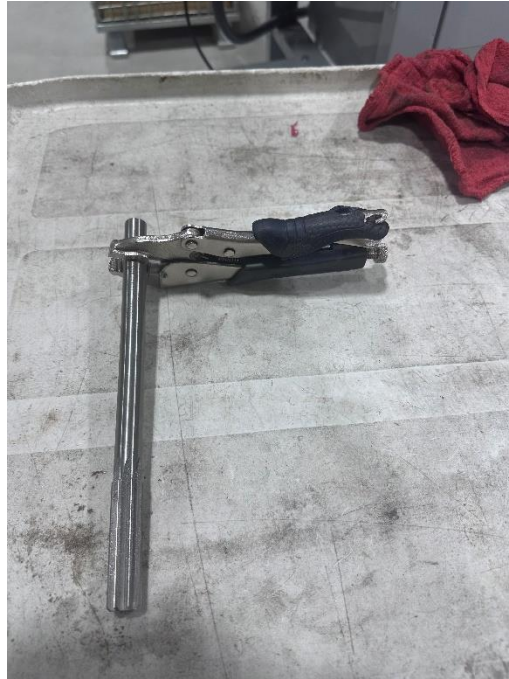
- 1) Use a .625" reamer to ream out the internal portion of the shaft. Do not use a drill, clamp a set of vice grips onto the shaft of the reamer.

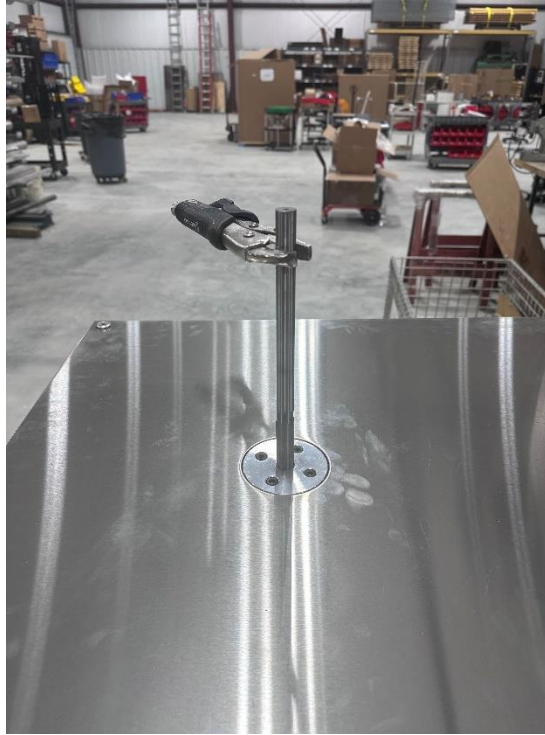
- 2) Turn reamer by hand until reamer has bottomed out on the internal pin (approximately 2.25" down). Remove reamer and use compressed air to blow the debris out.

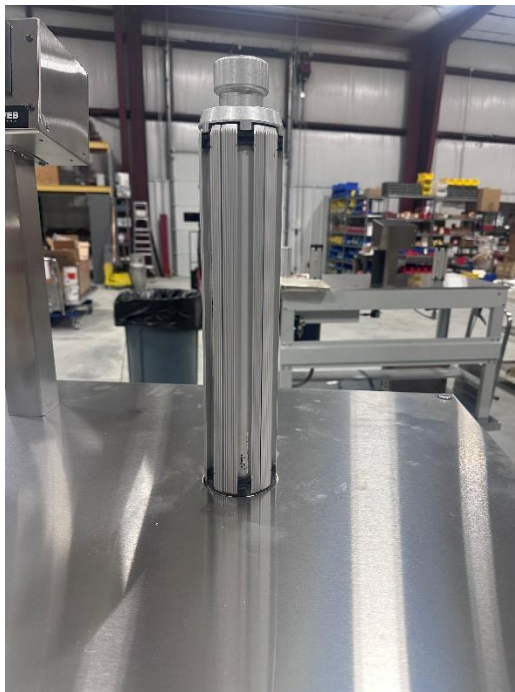
- 4) Place coreholder into system, if coreholder does not sit flush repeat the steps above.
